NASHAWANNUCK POND WATERSHED RESTORATION PROJECT

Project No. 1998-05/319

Prepared by
Pioneer Valley Planning Commission with the
Nashawannuck Pond Restoration Project Advisory Committee

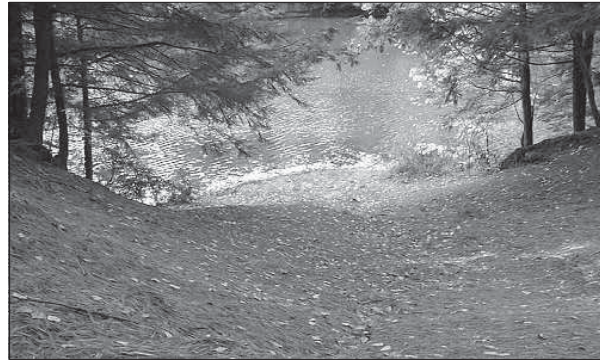
Pre-existing bank conditions at stabilization Area 2.

The stabilization of Area 2 involved the installation of a landscape timber stairway with a bark mulch path. The terraced plantings located on either side of the stairway were planted with mountain laurel, hemlock and highbush blueberry. Additionally, 18 lf of unvegetated stone walls and 35 lf of vegetated stone walls were installed to support the bank. Approximately 12 cubic yards of soil were removed from the end of the peninsula, restoring the Pond edge adjacent to the new stone walls. An existing footpath to the site was repaired and regraded to direct runoff to an existing low area. The surface of the path was repaired with wood bark mulch. The City intends to replace the gate with boulders to prevent motor vehicles from accessing this site.

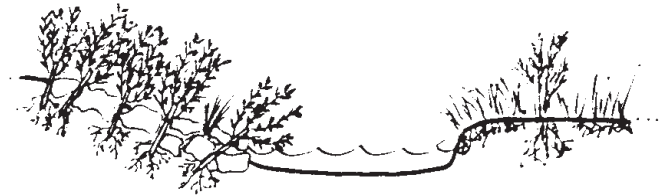
- Streambanks can be stabilized by planting deep-rooted shrubs along the banks.

Streambank with deep rooted plants

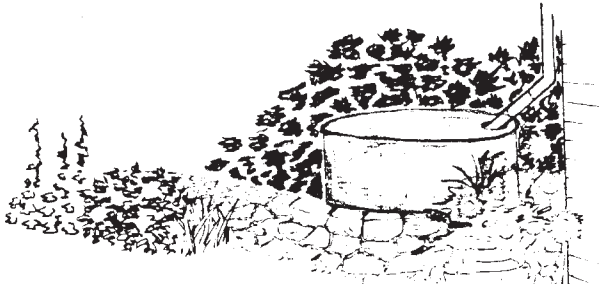
- Roof-runoff can be directed into a barrel for later use in watering lawns and gardens.
- Downspouts from roof gutters should be aimed away from foundations and paved surfaces.
- For roofs without gutters, residents can plant grass, spread mulch, or use gravel under the drip line to prevent soil erosion and increase the ground's capacity to absorb water.

Downspout into dry well

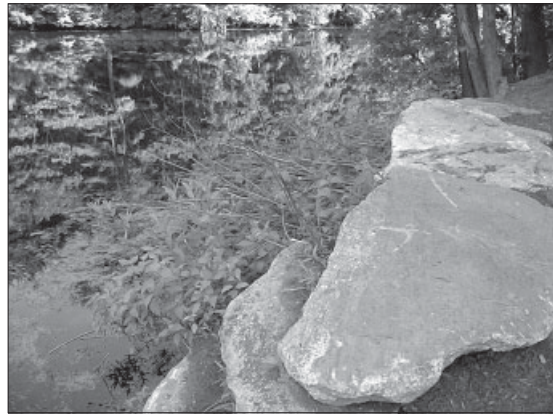
Vegetated Stone Wall constructed at Area 2.

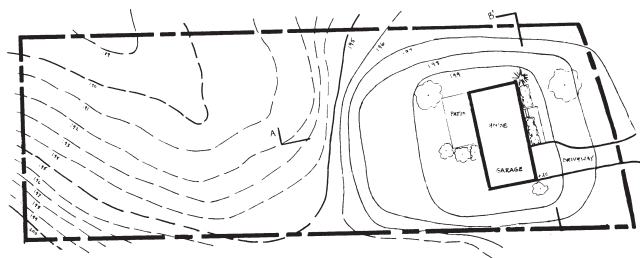
Typical Subdivision Lot Layout

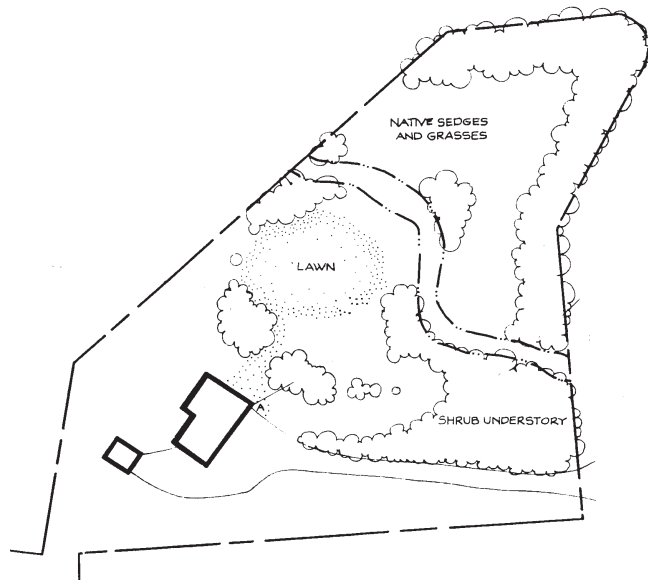
- Planting steep slopes with deep-rooted plants;
- Stabilization of stream banks with vegetation along the banks of the stream;
- Reduction of lawn area to reflect true recreational use;
- Placement of lawn area on the most level area to maximize the lawn's ability to hold and infiltrate stormwater thereby minimizing stormwater flow rates;
- Plant lawns with native sedges and other vegetation that do not require fertilization, watering or mowing.

Site 2 Demonstration Plan

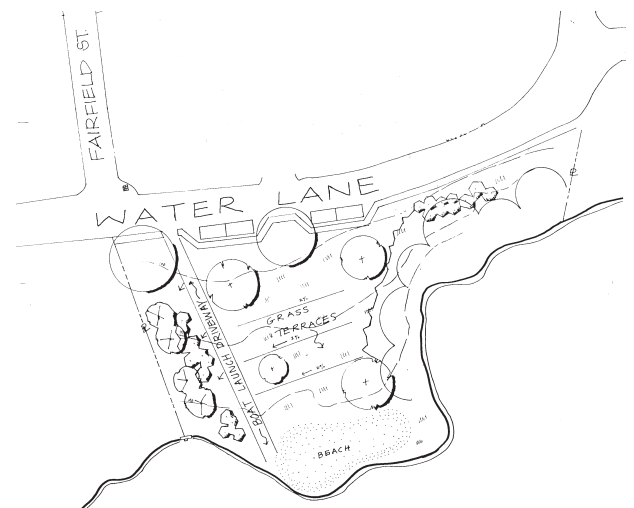
- Create a formal boat launch ramp;
- Provide parking just off Water Lane;
- Planting the southeastern slopes with woody vegetation;
- Discontinue all dumping practices including snow storage and residential yard wastes;
- Vegetate all soil surfaces with native species;
- Manage invasive exotic species;
- Create a vegetated swale or depression to slow down runoff and allow sediments to settle before reaching the Pond; and
- Stabilize the slopes with vegetation and terracing to reduce the risk of severe erosion.

Site 3 Demonstration Plan

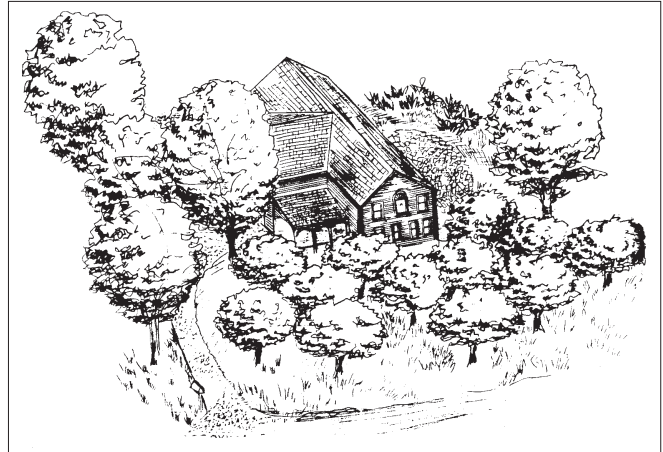
Site 1 Demonstration Rendering

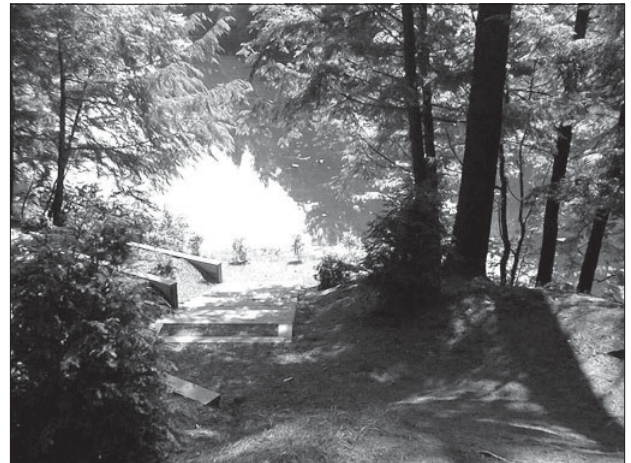
Bank Stabilization at the Westerly side of Area 3.

Stabilization activities at Area 3 - East included filling and regrading the path to the site to redirect runoff. Wood bark mulch was used for the surface of the path. Boulders were placed at the head of the path to prohibit vehicles from traveling on it. Vegetated stone walls (26 lf), unvegetated stone walls (40 lf) and spot stabilization with boulders (18 lf) were installed to stabilize the bank of the Pond. A timber slope check replaced 50 lf of eroded bank. Topsoil and mulch were added to 12 lf of bank. The recently downed tree was removed.
